# Groundwater Dependent Ecosystem Investigation

Kristen Kaczynski, PhD

Principal Investigator, Sub-Terra Heritage Resource Investigations

TEHAMA COUNTY  
Flood Control and Water Conservation District

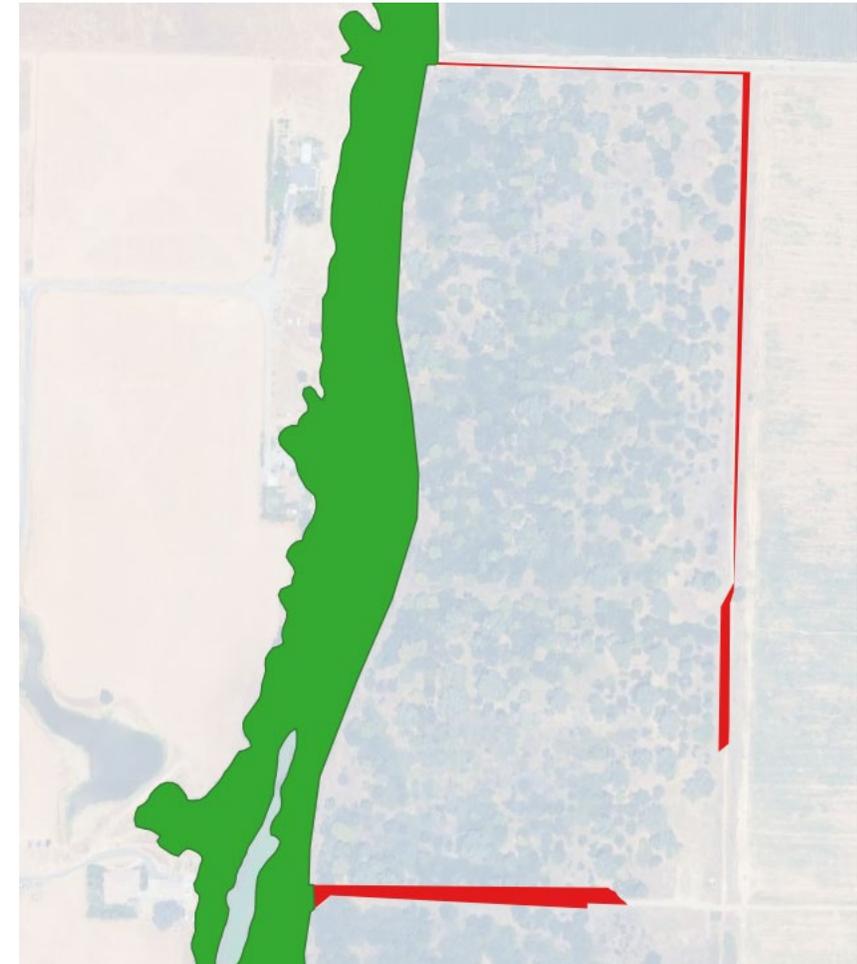
- Aerial analysis of each polygon
  - Vegetation and land use verification
- Used 2013 – 2024 DWR fall contours  $\longrightarrow$  interpolated surface
- NDVI long-term average for each polygon

We identified polygons that were ‘likely GDEs’ and ones which were ‘not likely GDEs’ to refine the areas that should be monitored in the future

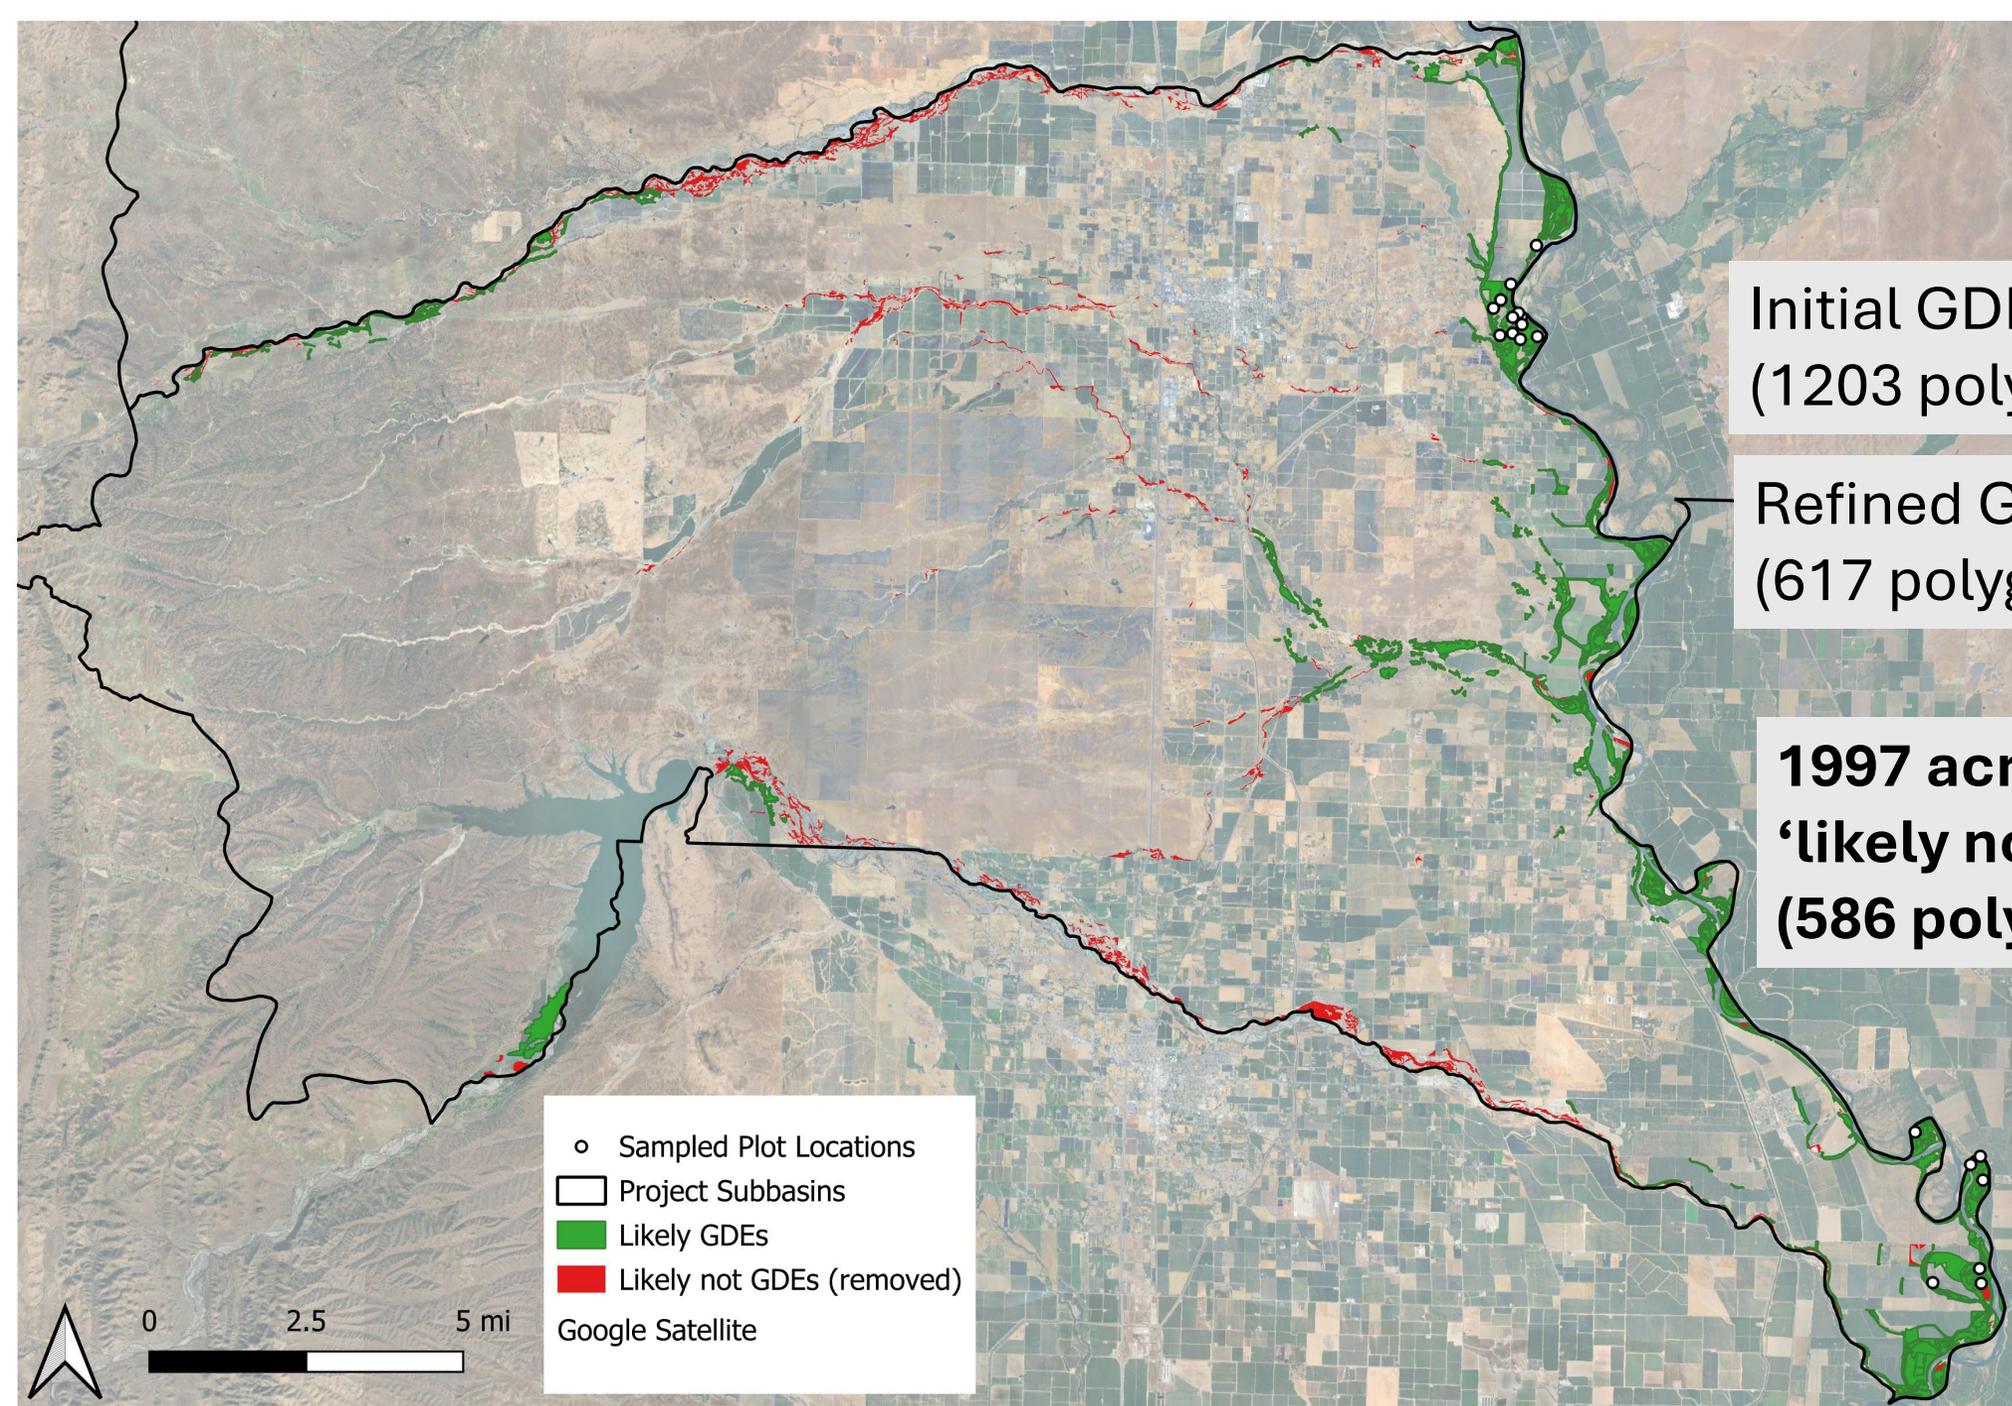
Initial GDEs: 6472 acres  
(1203 polygons)

Refined GDEs: 4475 acres  
(617 polygons)

**1997 acres classified as  
'likely not GDE'  
(586 polygons)**

- Sampled Plot Locations
- Project Subbasins
- Likely GDEs
- Likely not GDEs (removed)

<b>Initial GDE database (TNC)</b>	<b>Likely not GDE</b>	<b>Classified as GDE</b>
<b>Antelope</b>	1451 acres	<b>73 acres</b>	<b>1379 acres</b>
	254 polygons	<b>32 polygons</b>	<b>222 polygons</b>
<b>Corning</b>	6472 acres	<b>1997 acres</b>	<b>4475 acres</b>
	1203 polygons	<b>586 polygons</b>	<b>617 polygons</b>

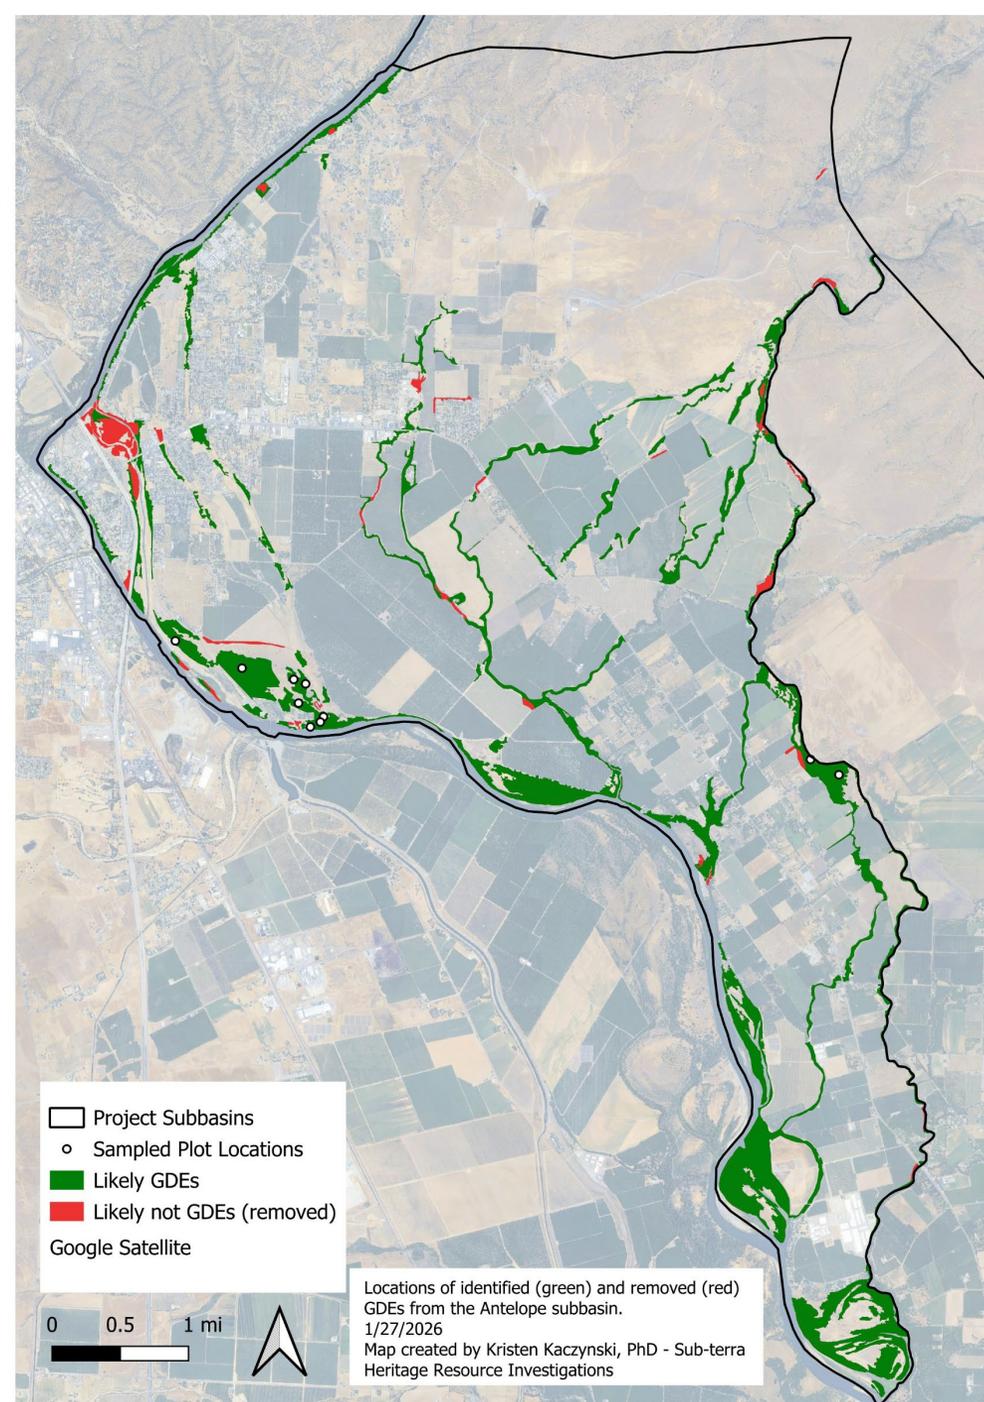
Initial GDEs: 1451 acres  
(254 polygons)

Refined GDEs: 1379 acres  
(222 polygons)

**73 acres classified as ‘likely  
not GDE’  
(32 polygons)**
